Enhancement Concept Diagram Lower Willow Creek (Reach 7): **Alternative A**

Waterway Assessment Results

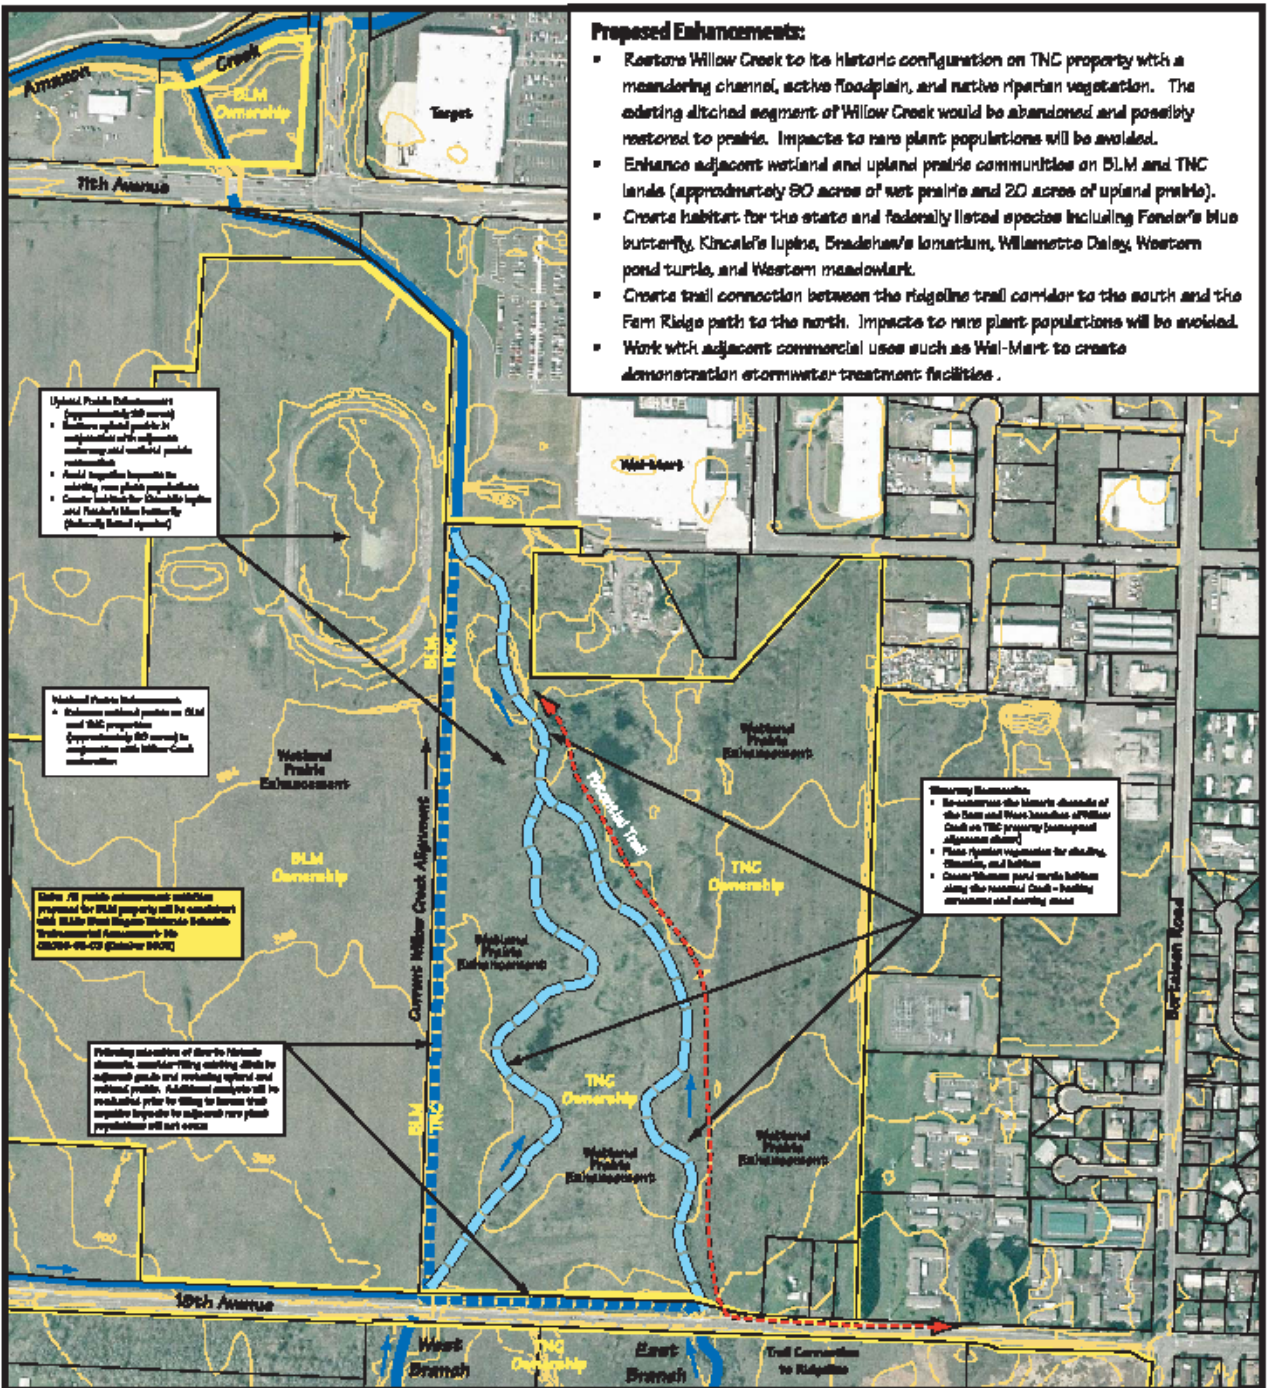
- Existing Waterways
- Tax Lot Lines
- Land in Public or The Nature Conservancy Ownership
- Proposed Enhancements**
- Waterway Restoration/Re-alignment
- Existing Channelized Waterway to be Abandoned
- Trail Connection from Kluge to Farm Ridge Path (conceptual)

Physical Condition	Water Quality	Natural Resources	Restoration	Total Points
Highest Possible Score	40	40	50	50	180
Existing Score	5	5	31	22	63
Projected Score*	32	32	44	22	130

*Projected score is based on successful implementation of the enhancement proposal in the alternative shown.
